Blanco Wash/ Old Meadow Lane Culvert installation

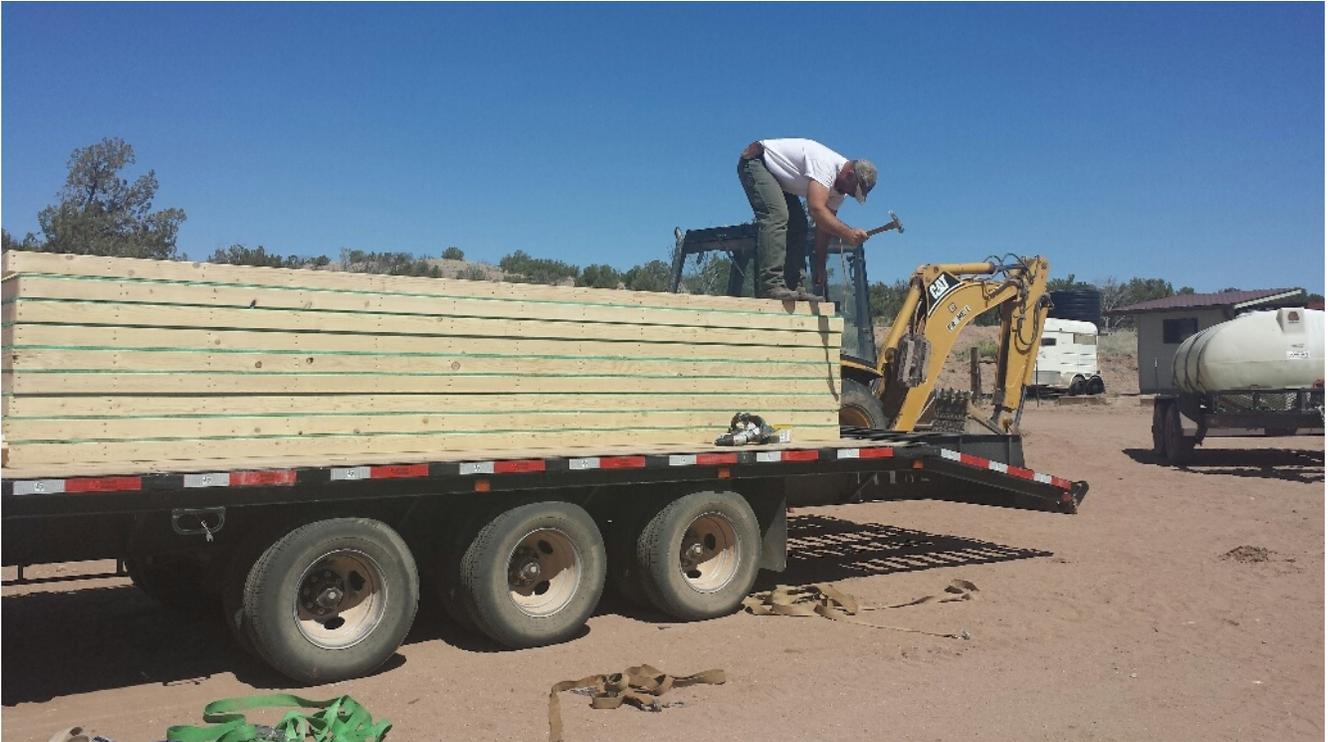
Building concrete forms on a trailer for easy transport to job site.

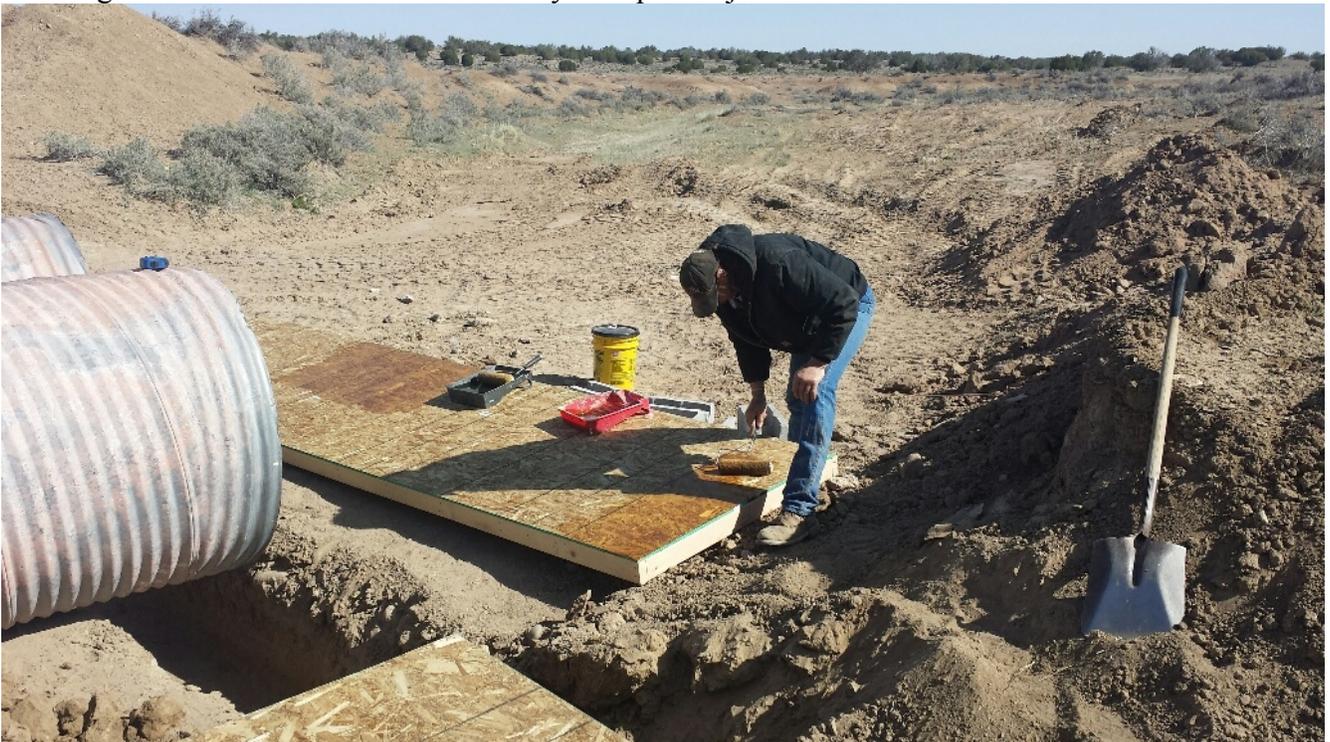
The wash bottom was graded flat to accommodate these five 48" diameter culverts, here a laborer is oiling a form so the poured concrete will not stick to the form when it is removed. Note the trench under the end of the culvert, the form sits down inside the trench flat against the end of the culvert. When the concrete head and end walls are poured the concrete will extend two feet below grade. This photo is looking upstream. Note: the flatter/wider wash bottom will accommodate more water flow allowing runoff to spread out as it reaches the culverts thereby lessening the speed of the flow while allowing less depth at the culvert location. This maximizes the flow capacity of the culverts.

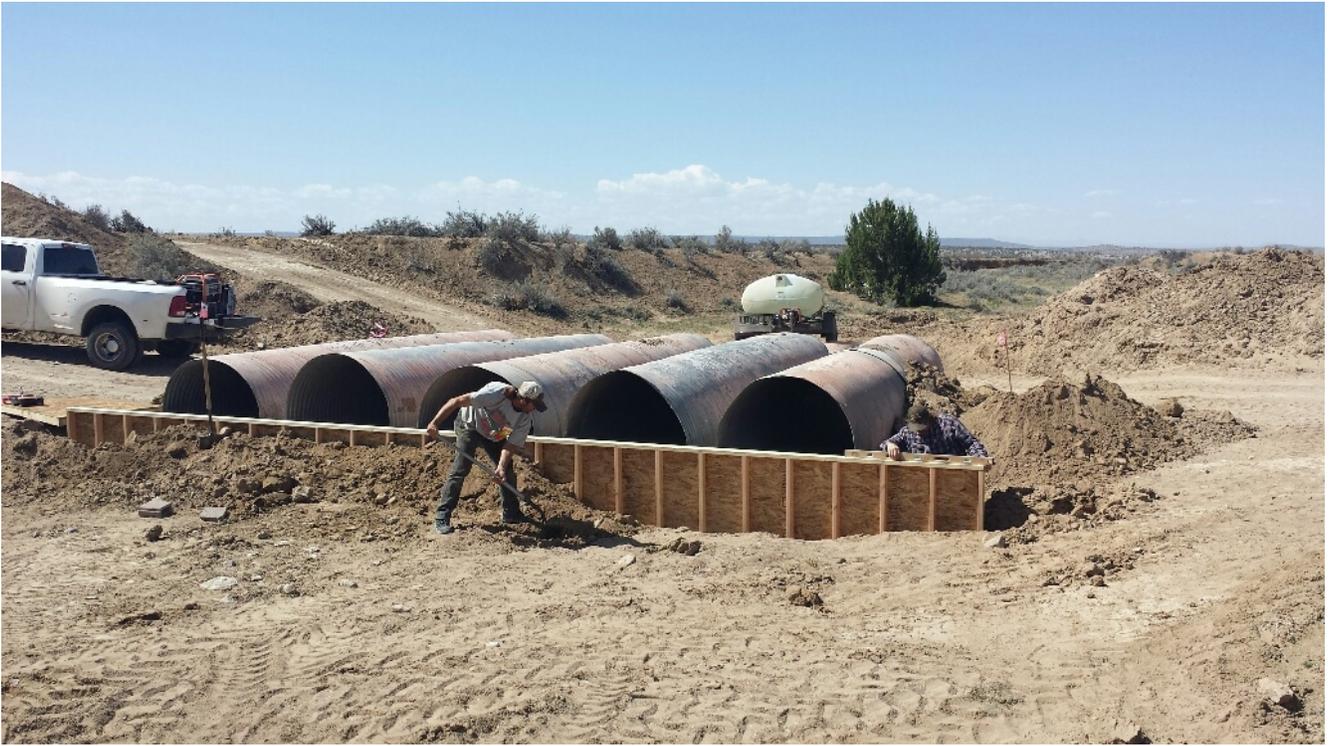
This photo shows the bottom row of forms installed in the trench, most of the back filling is done by backhoe but some must be done with a shovel. Each of these forms are 4'x16', two are installed here. Water trailer in the background is used for water compacting soil.

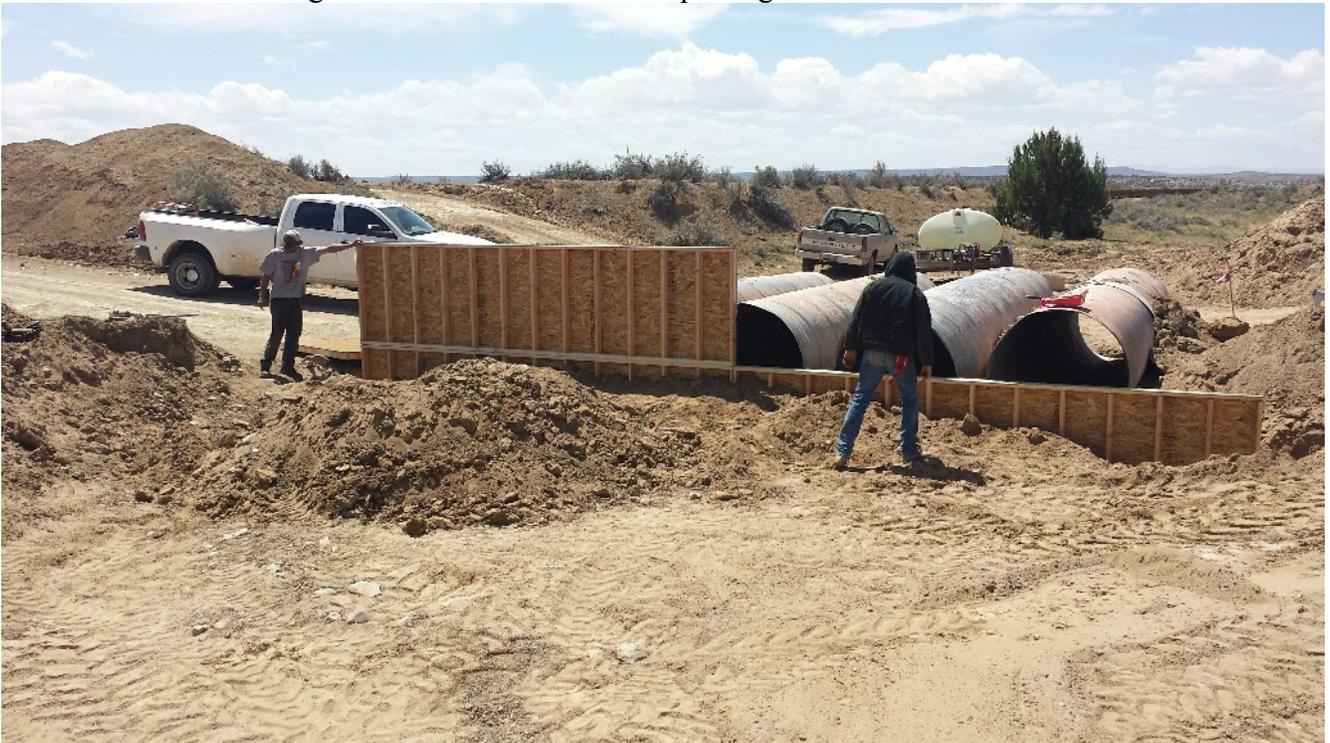
Here the second row of forms is being installed.

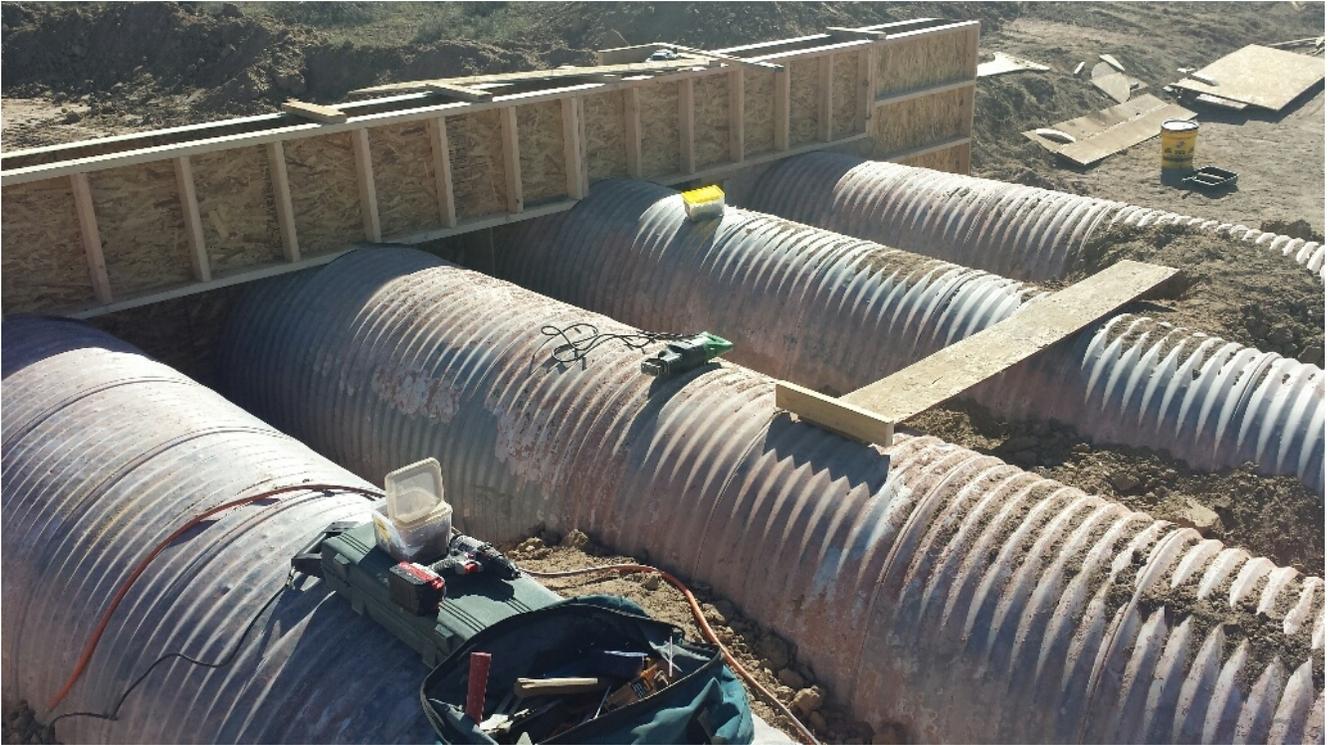
Here the inside wall forms are being installed, note the void underneath the form between each culvert, this must be filled with individual and intricately fabricated flat boards. Note how the form is tailored to each culvert on the bottom where it rests on top of each culvert so the form sits level. This was a lot of extra work because we used old used culverts that were bent, twisted and “out of round”. We tried to make the culverts on each end as round as possible by squashing them with the backhoe and banging the ends around with sledge hammers the way a body man fixes a fender on an automobile, this was somewhat successful but created no real uniformity from end to end.

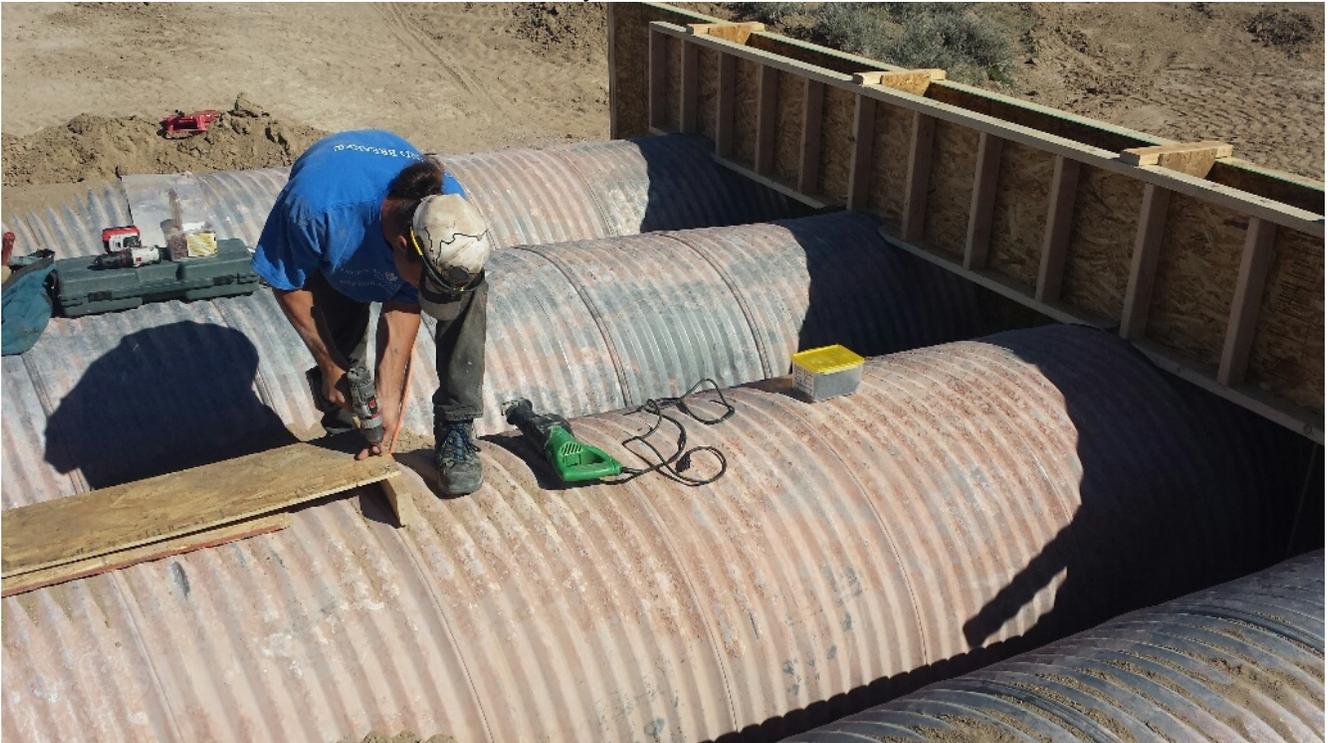
Another photo showing fabrication of the concrete forms, voids between the culverts not installed yet.

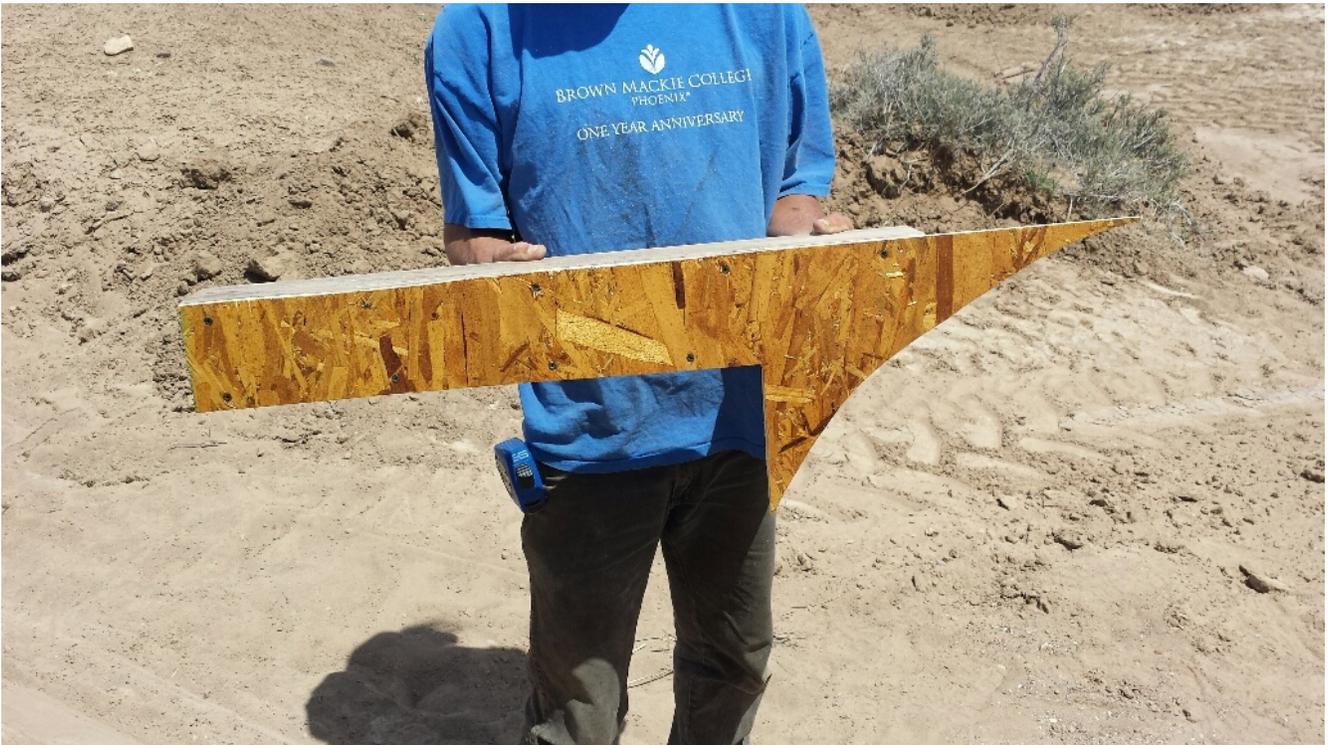
This shows a minor level of intricacy necessary to build these forms and to prevent concrete from leaking into the culverts during the pour. This will be attached next to the culvert (note the round portion) to prevent leakage of concrete into the culvert as it is being poured.

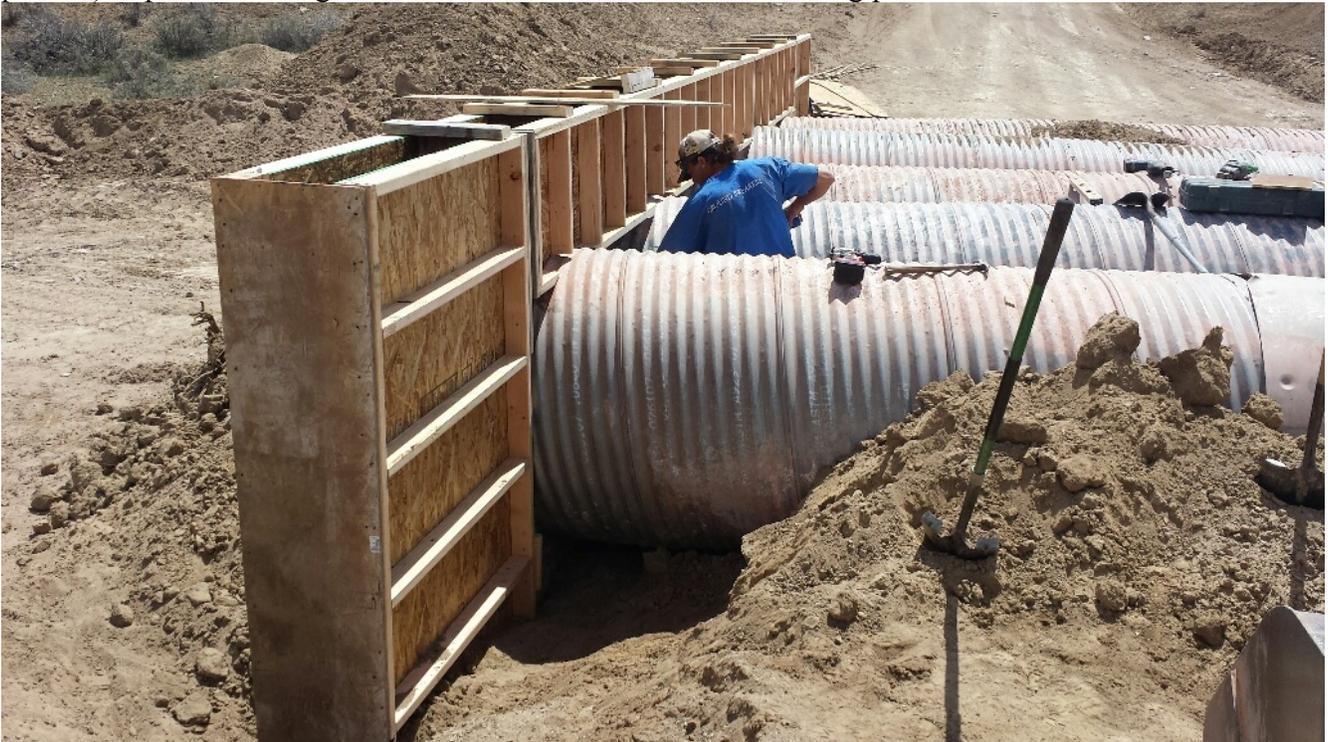
Here back-filling by hand takes place with a shovel, in this photo the forms extends two feet below the level of the visible soil (two feet below the bottom edge of the culverts).

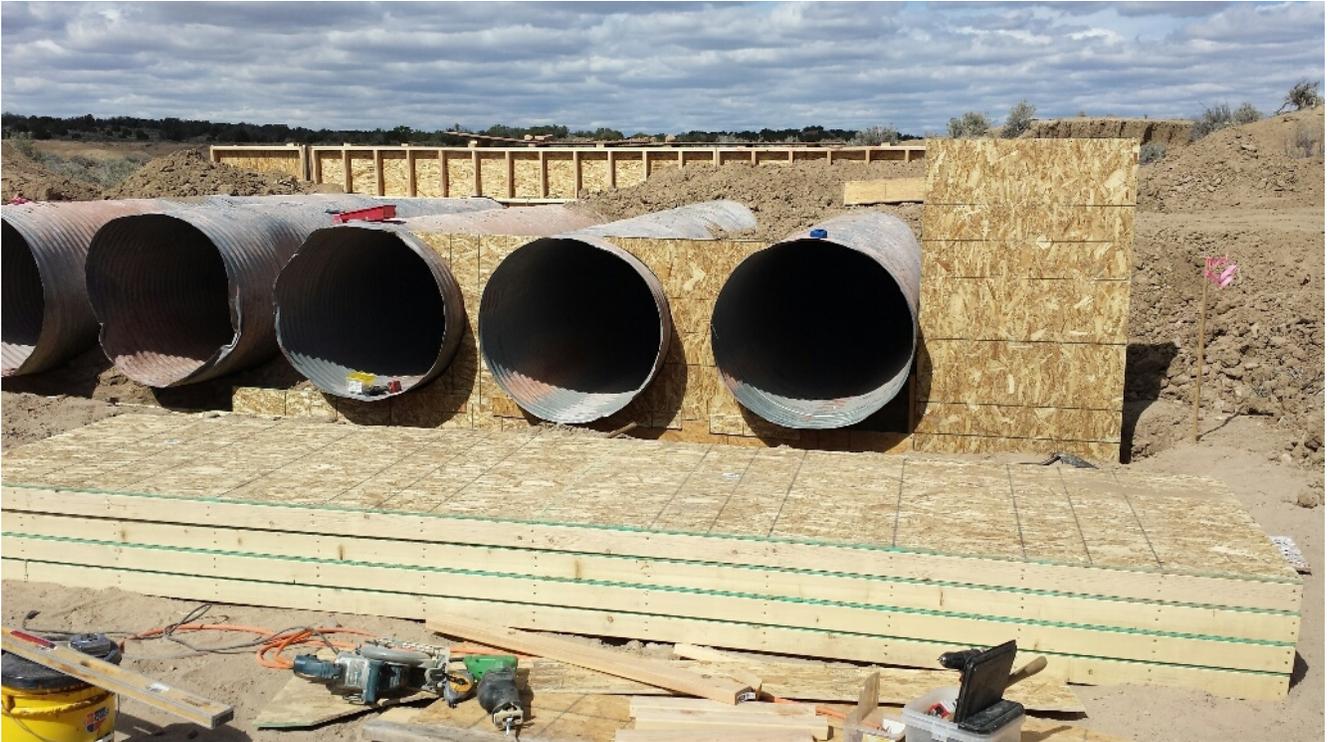
This photo shows the individually fabricated “hourglass” shaped flat boards between the culverts that form the inside wall of the forms. Note how each culvert extends beyond the inside form.

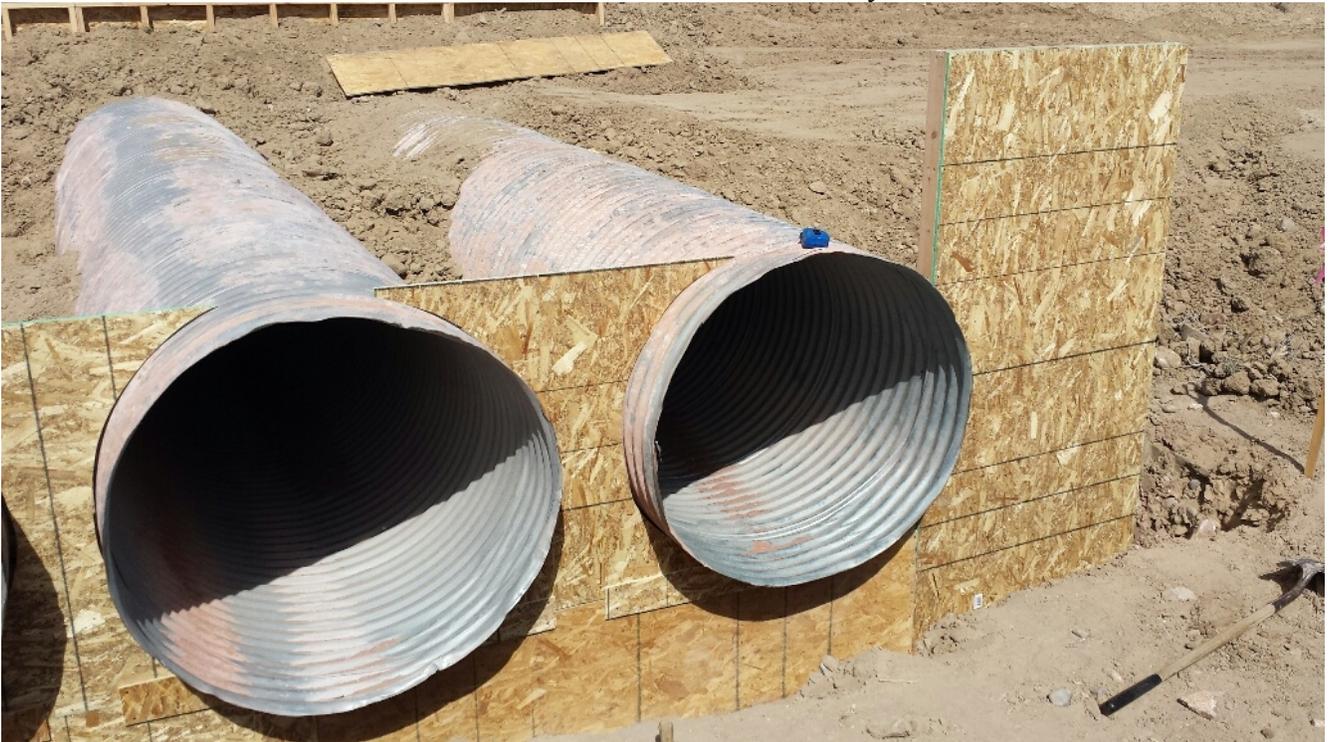
This photo shows the forms extending below grade. The interior flat boards cannot be removed, they will eventually deteriorate on their own and provide no structural benefit after the concrete is poured. It would have been easier to simply fill the spaces between the culverts completely with concrete, this would eliminate the time consuming effort to fabricate the inside form walls but would be much more expensive due to increased concrete volume, approximately \$10,000.00 more.

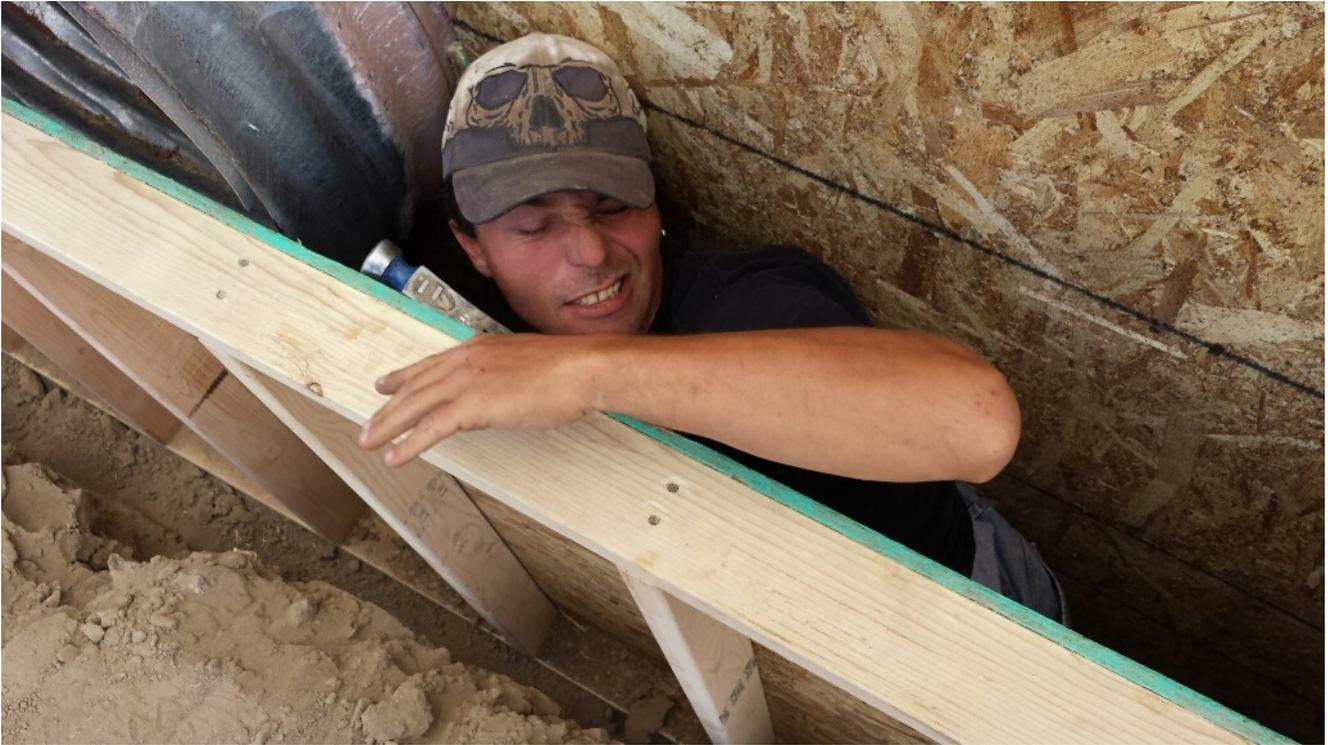
Here one of my laborers has had to crawl into the 10" wide cavity to install a rebar reinforcement to prevent the inside wall from caving in due to the weight of soil behind it. He is exiting the form now but had to reach four feet below the level of his head to accomplish this task. It was an oversight this happened in the first place, I have high praise for this individual that could perform this need. If not for his flexibility and lack of claustrophobia we would have had a LOT more labor to remove/rebuild the form.

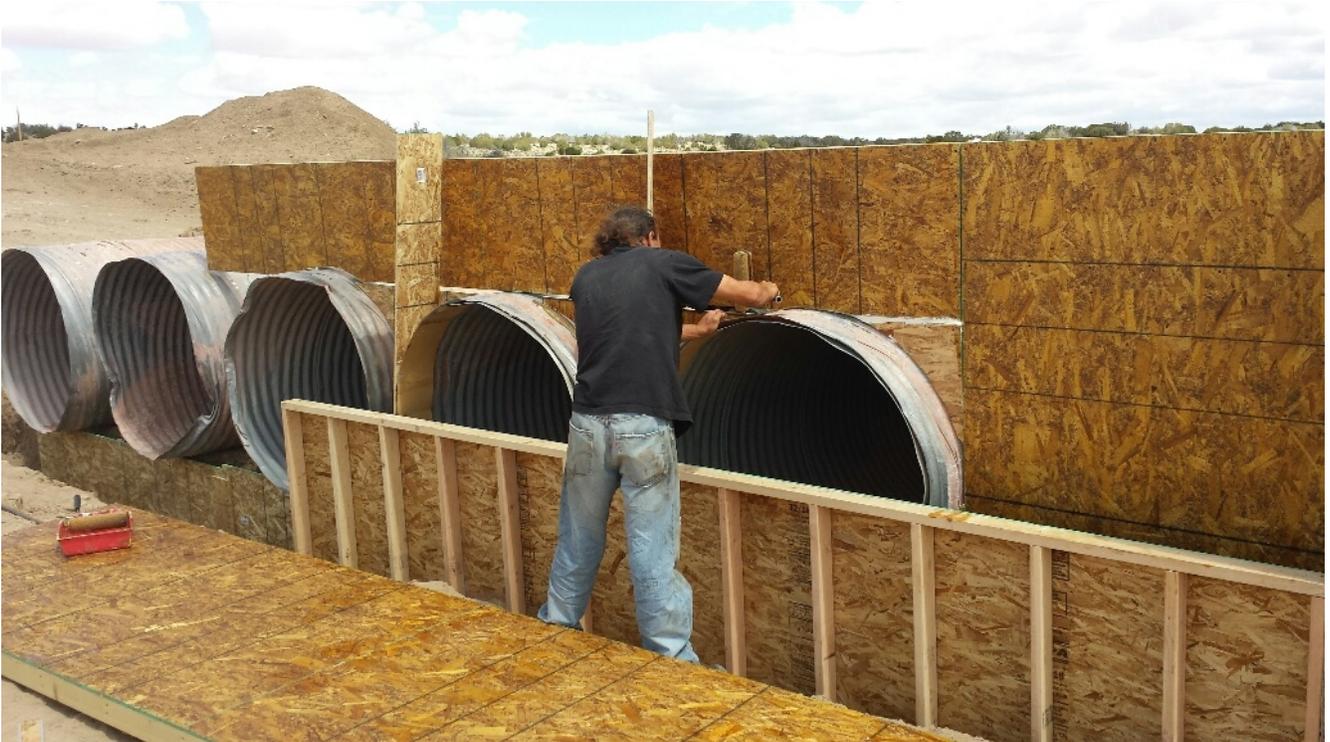
Oiling forms. Not shown in any photos, it was necessary to seal two men into each culvert with the top form in order to install aluminum strips to compensate for the bent culvert ends. Paper lined aluminum strips can be seen in the second culvert from the right and at the extreme right edge of the right culvert. Note how the culvert second from left is bent up, if not for these aluminum strips concrete would have leaked into the culvert during the pour. This was a tedious, hot, time consuming process, thankfully none who performed this task had claustrophobia. It took four men to accomplish this task.

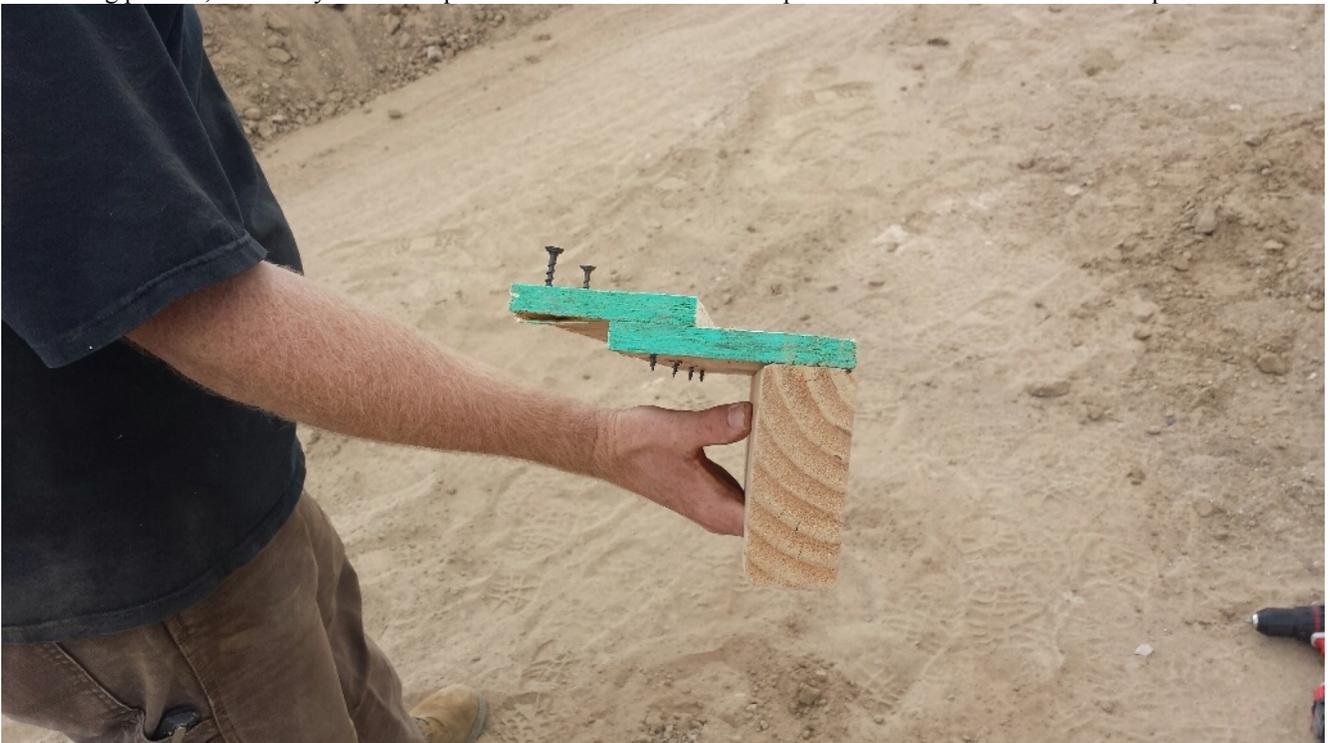
Another intricate piece that took a lot of thought, in and out of a tight place many times, measuring, figuring, a lot of trial error to get it right. This was to keep concrete from leaking into places we didn't want it to go. The smaller pieces required more thought than the larger pieces. One has to take into account how to remove the form once the concrete has set up.

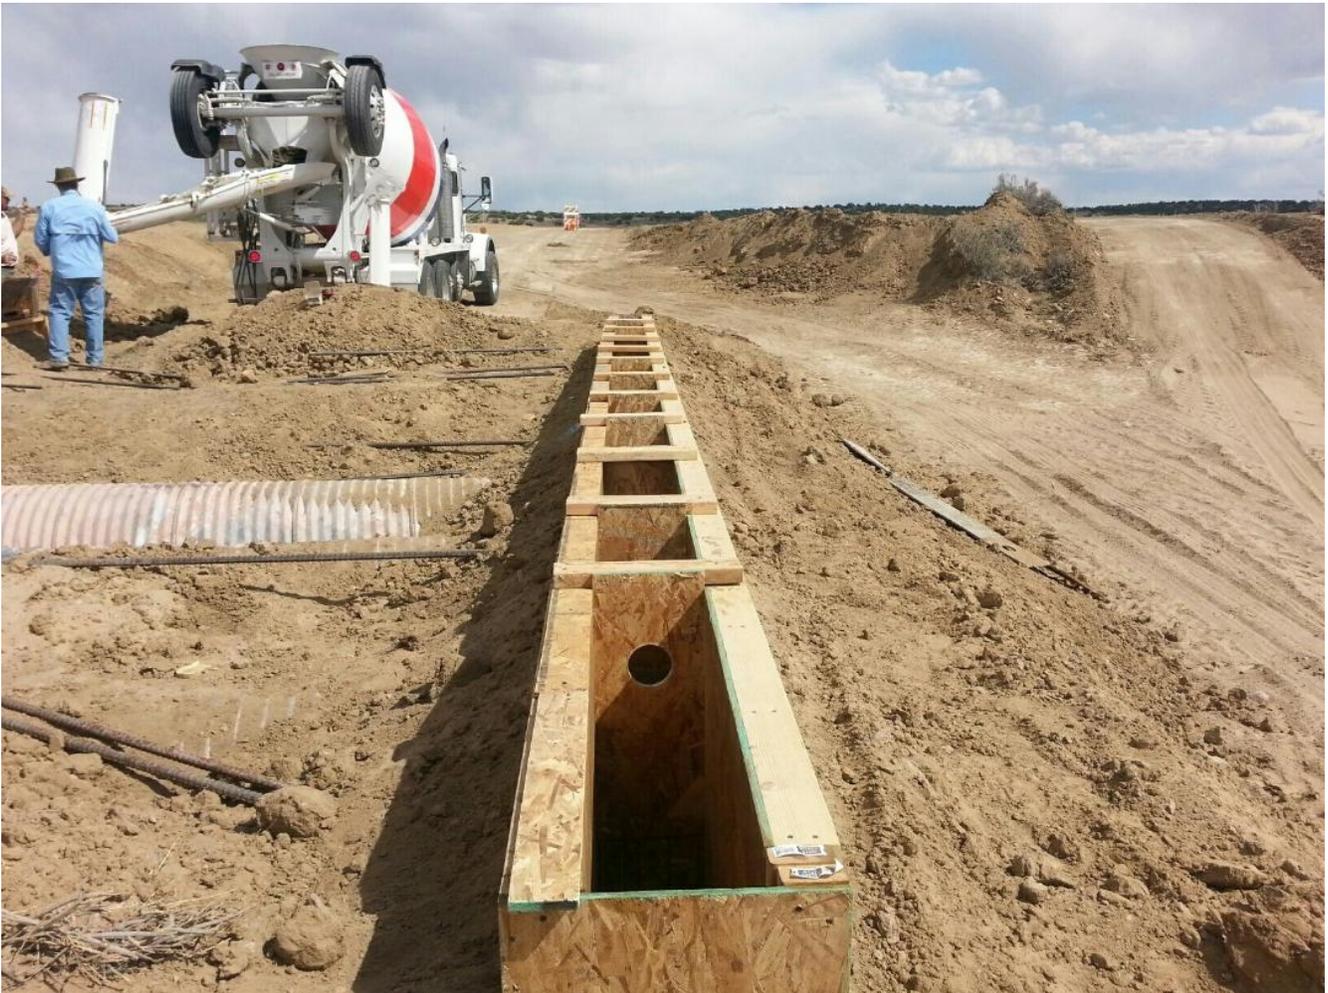
This is form is ready to pour. The spacers, shown with a hole will be removed as the concrete is poured. The spacers hold the form apart until the concrete is in place. Note the earth piled up on both sides of the forms, this is much less expensive than wood or steel bracing, it is free and took only about half an hour with a backhoe to place. Wood or steel bracing would have cost more, not only to install but to fabricate, the soil was free. This was the most cost effective way to build this structure. In this photo only about 12” of the form can be seen, it actually extend about seven feet below what can be seen here.

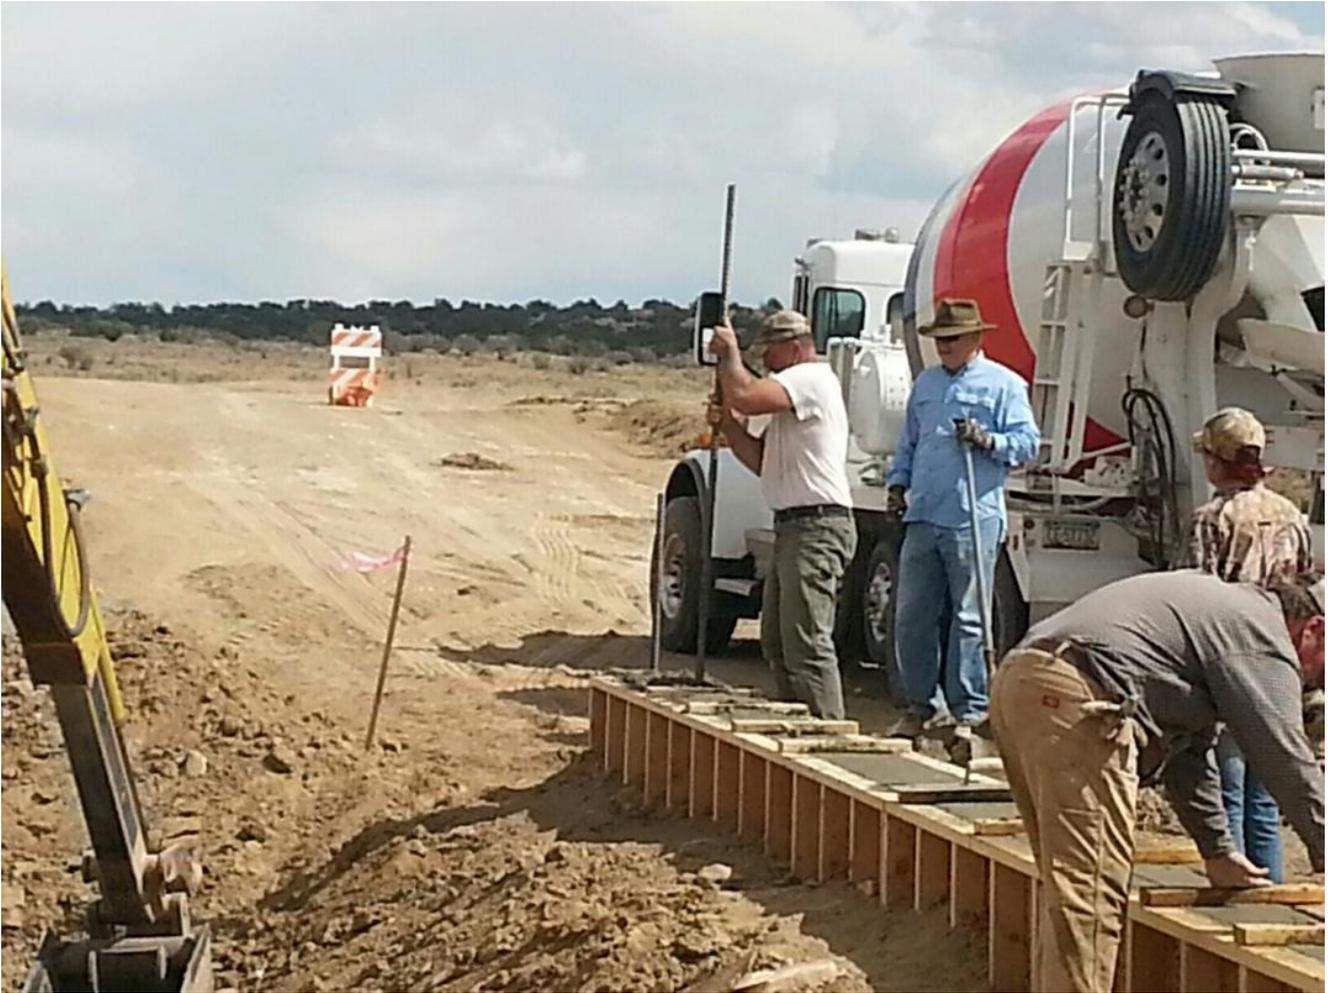
With the volunteer help of WVR property owners and board members the concrete pour was made much easier and less costly. Here rebar is being installed vertically at the culvert ends, there is both horizontal and vertical 1-1/8" rebar inside the concrete. My special thanks to Jake Tormolen, Mike McDowell, Angel Palmer, Dean Rachwitz and Zolin Moses for their help.
(continued)

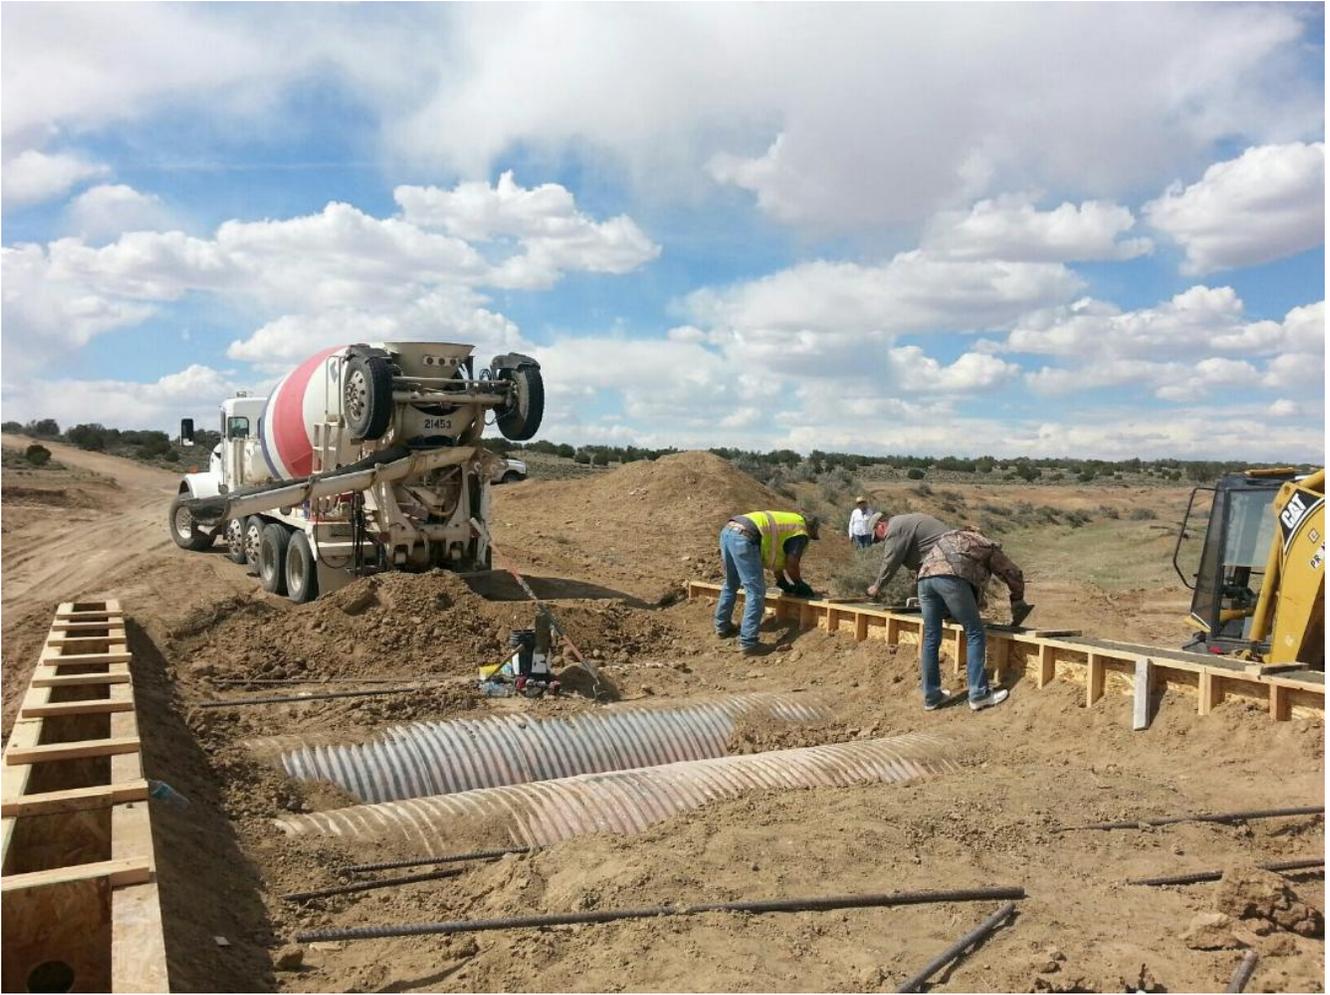
Here even the concrete truck drivers lend a hand. Note the heavy rebar laying about ready to be installed.
(continued)

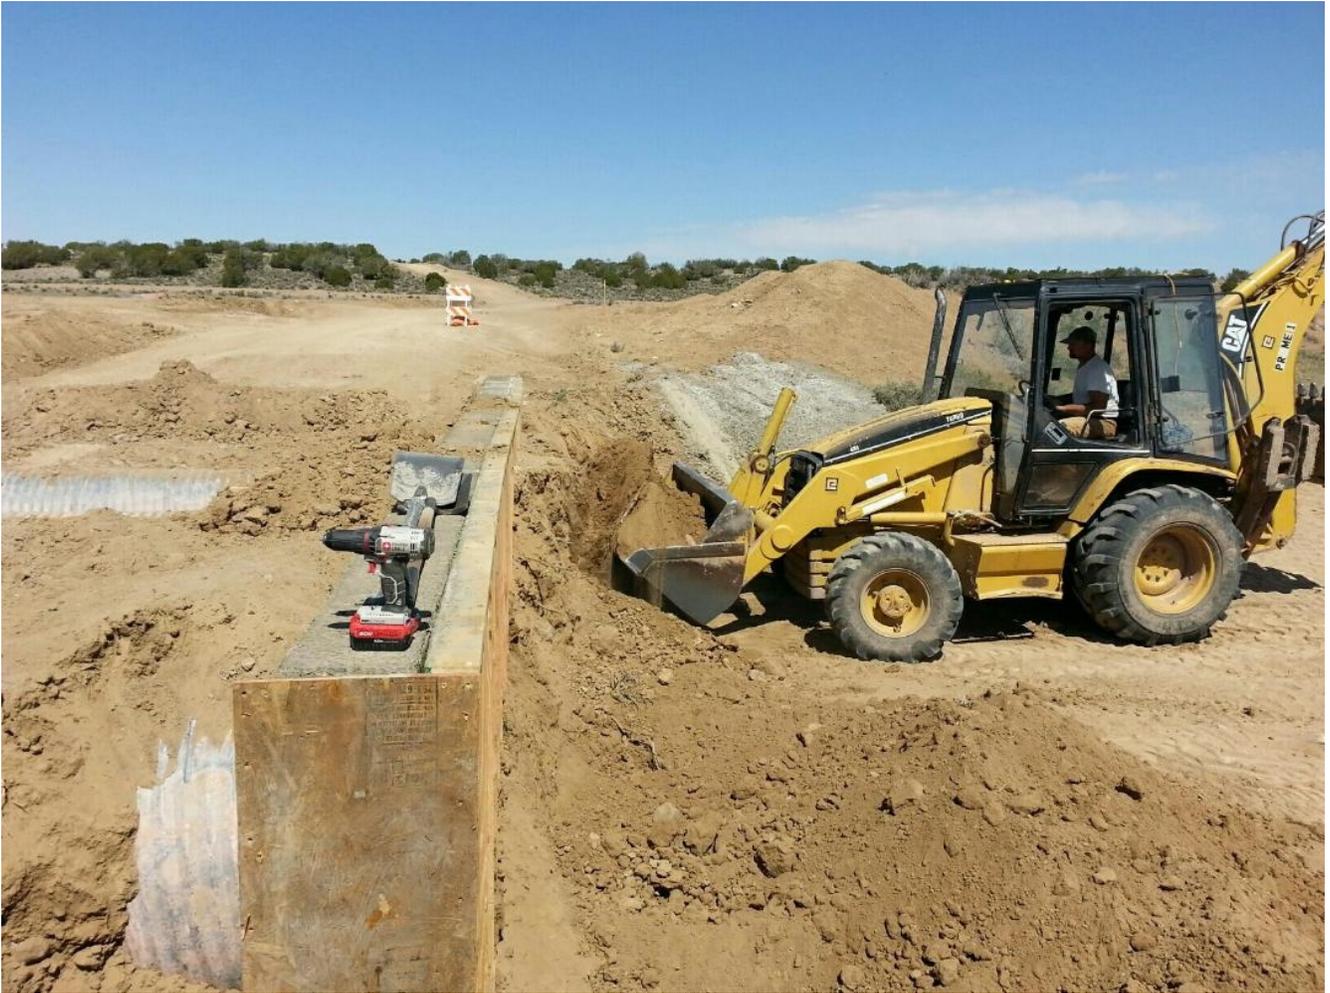
The concrete has set up hard, here we begin to remove the soil that held the forms in place.
(continued)

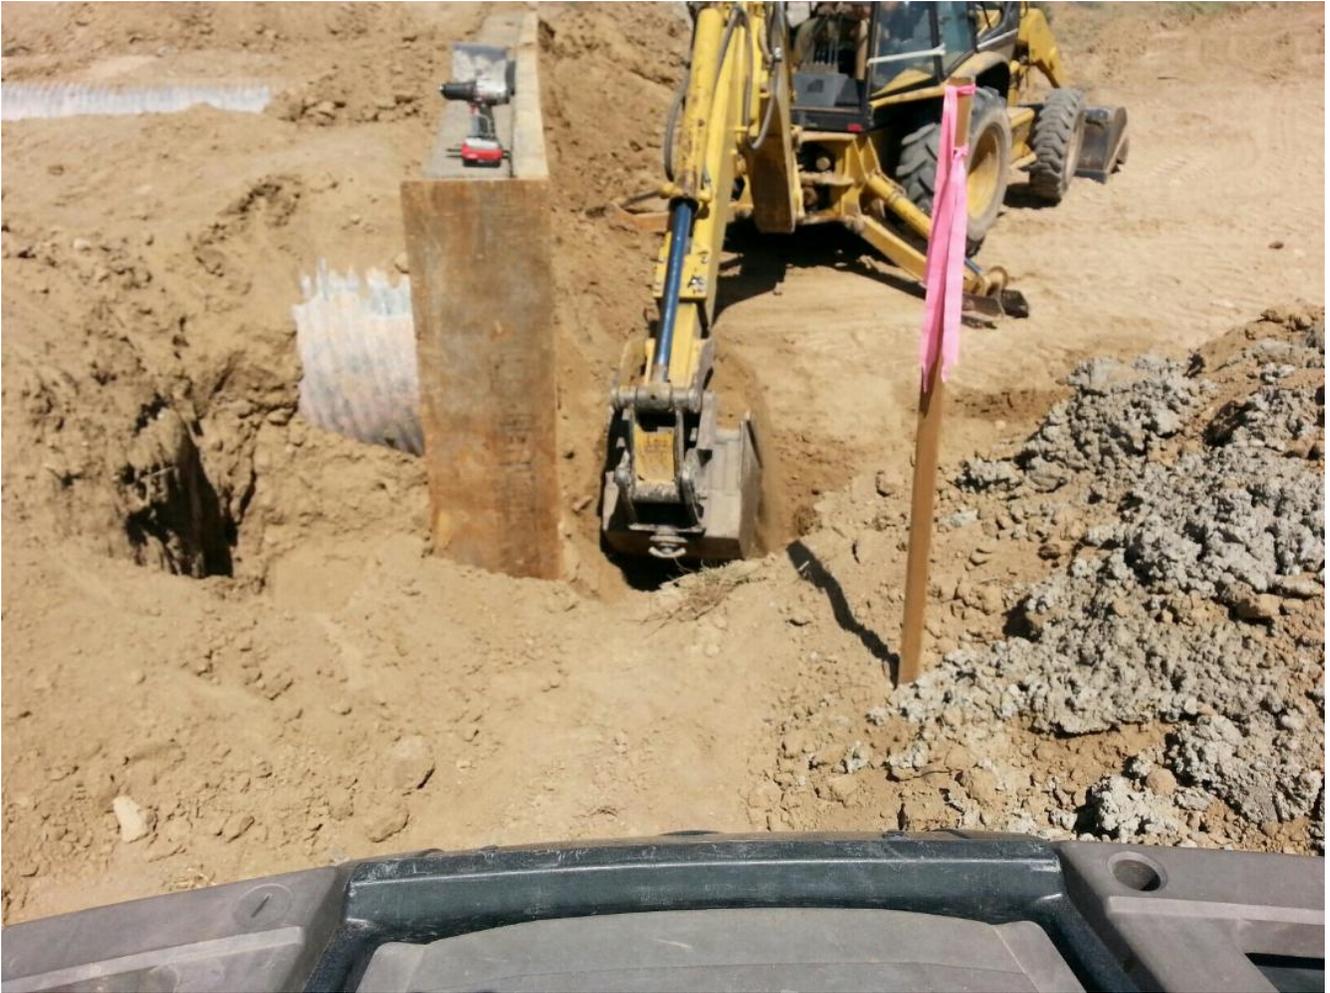
And here excavation below grade begins to access the bottom forms.

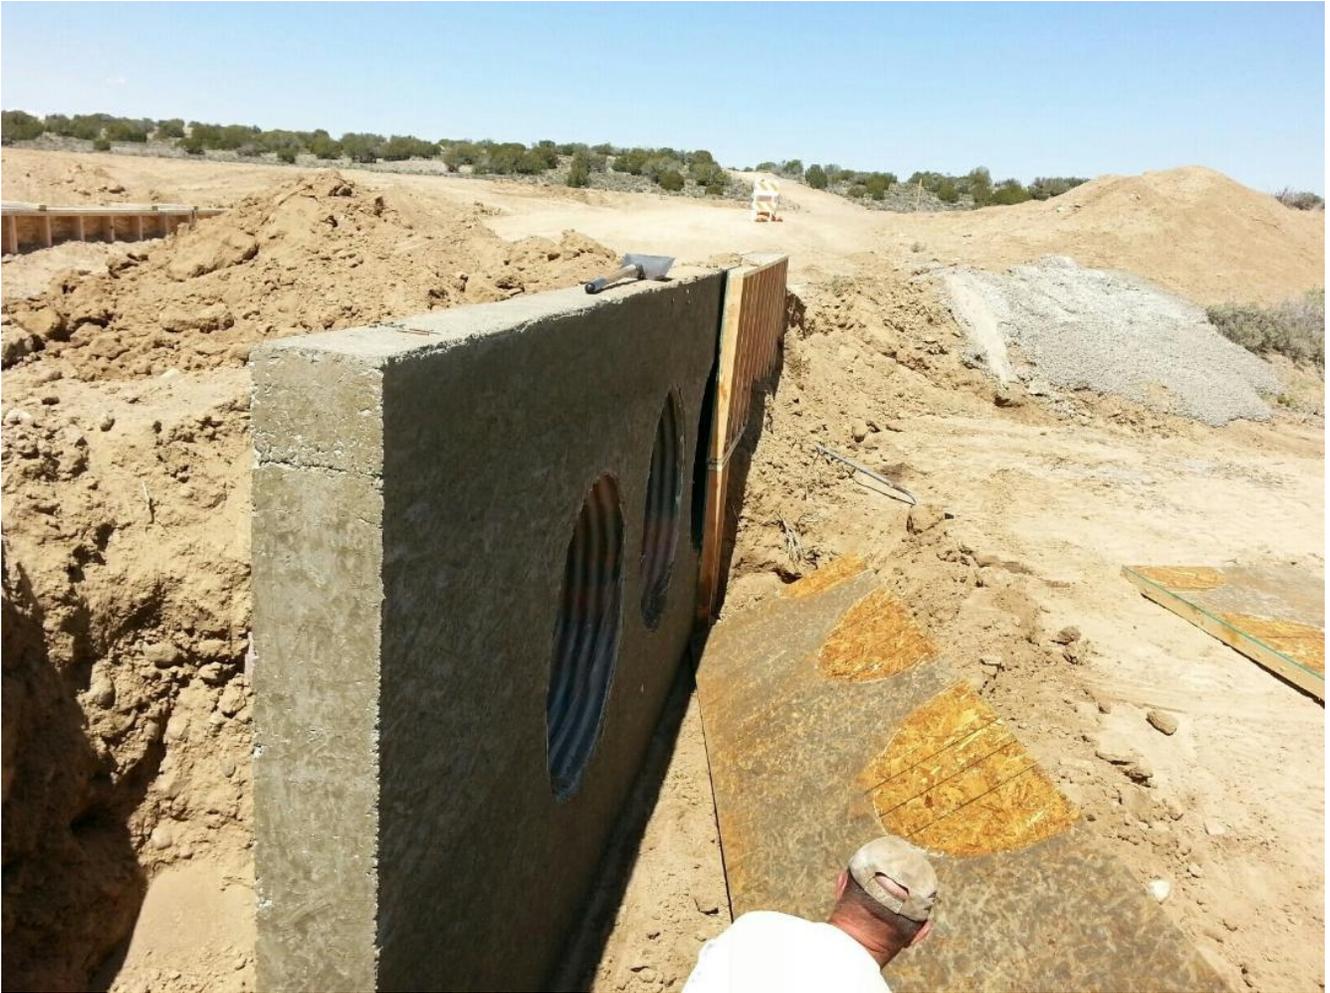
Here one of the bottom forms is being removed.
(continued)
