Blanco Wash/ Old Meadow Lane Culvert installation

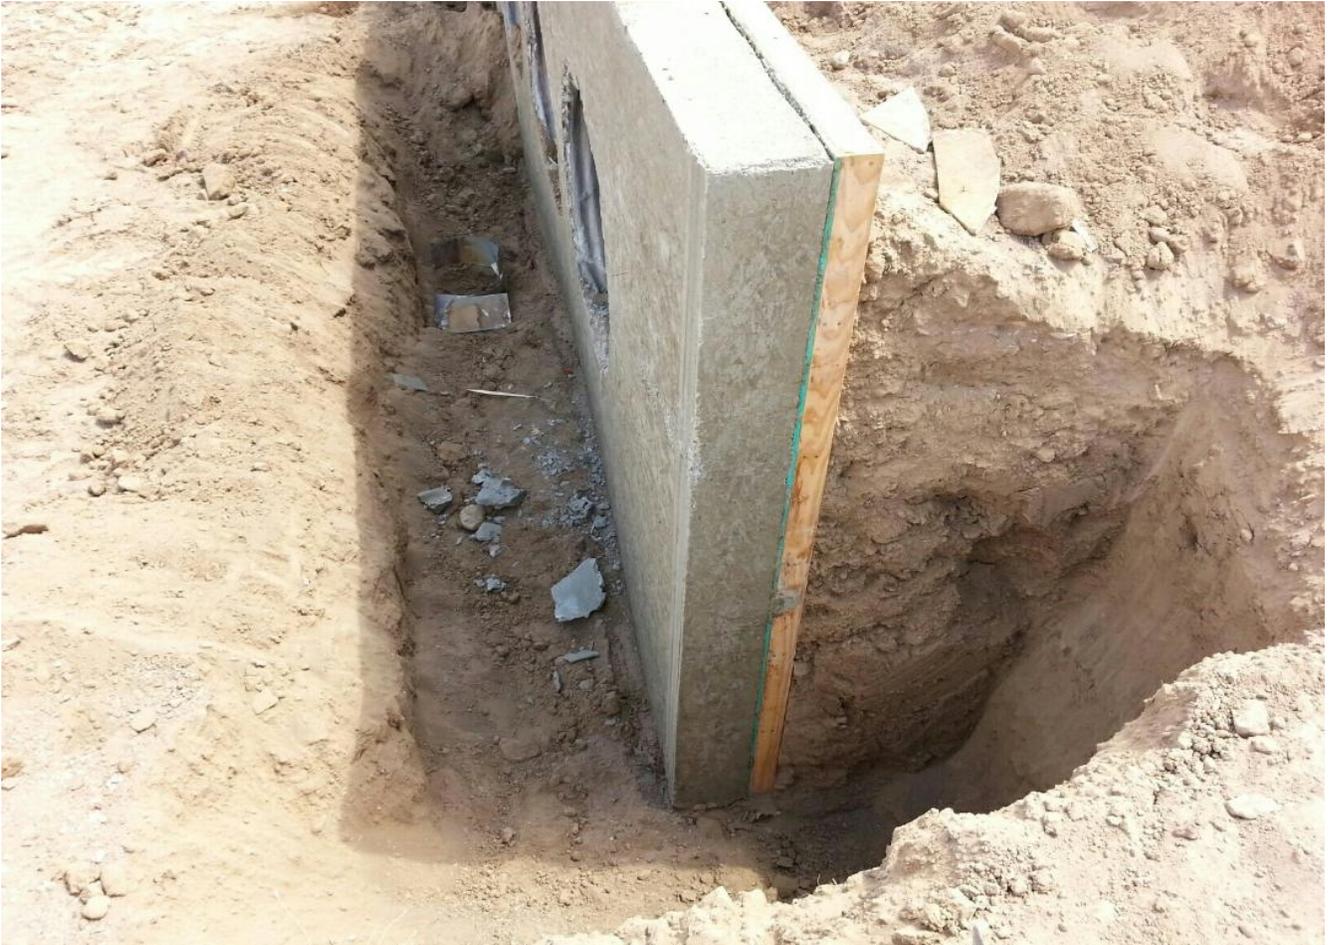
The concrete head and end walls are 10" thick, 36.5 feet long and 8' high, two feet below grade, two feet above the top edge of each culvert.

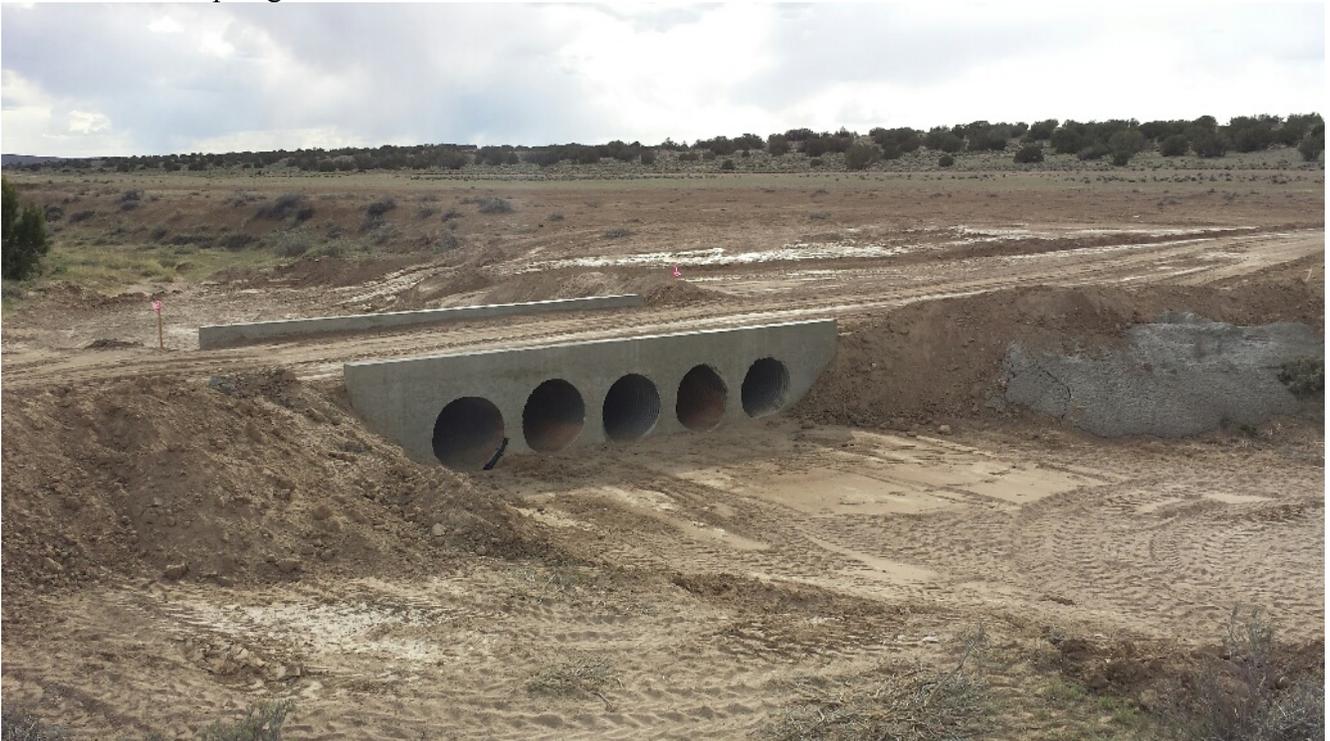
The completed project looking downstream. (continued)

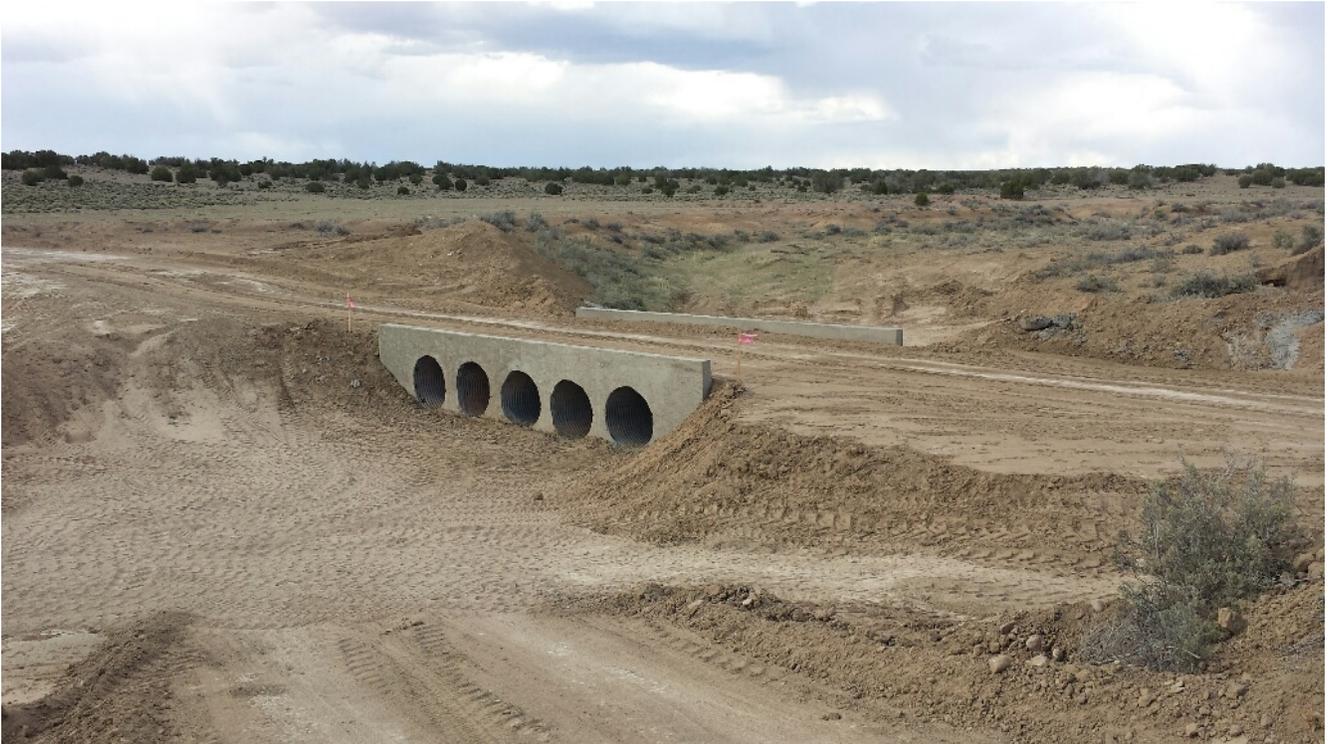
Looking upstream.

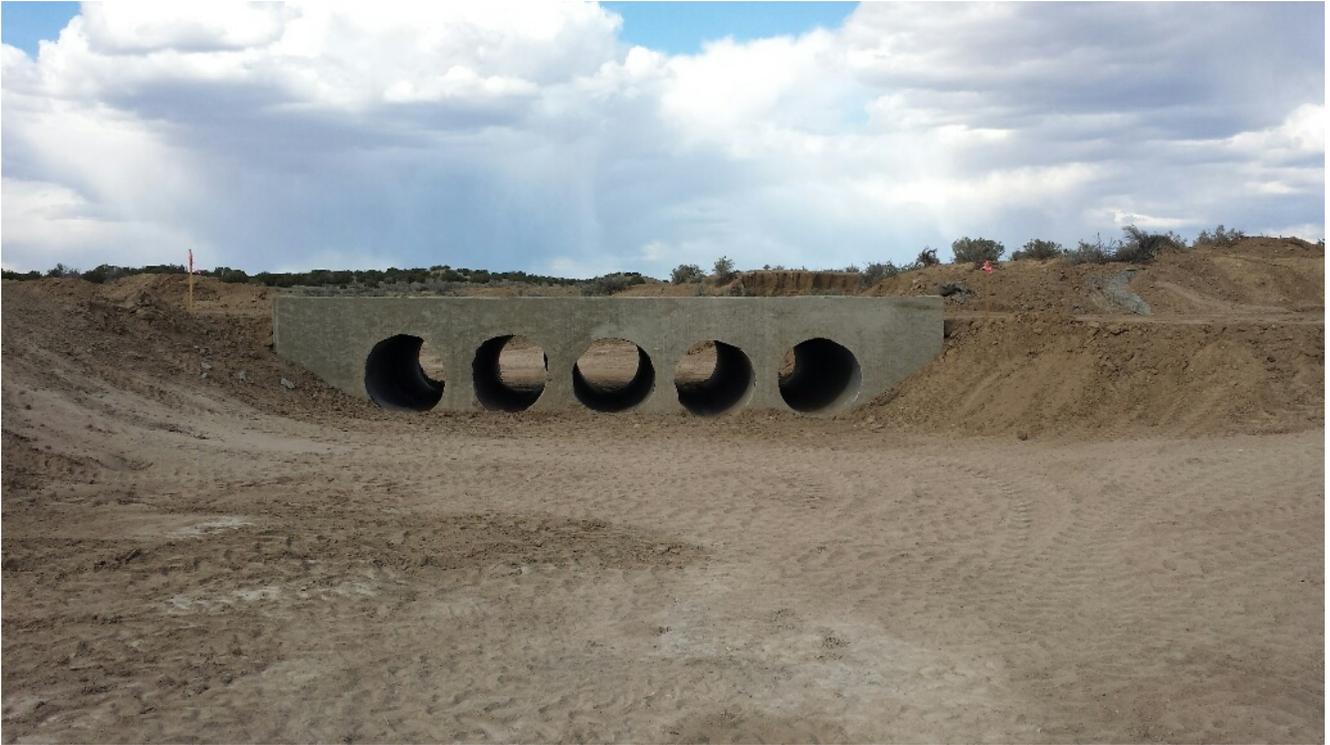
An end view, note how the culverts are not uniformly round. Using these old bent, twisted culverts did save some money in spite of the extra effort expended to fabricate around them.

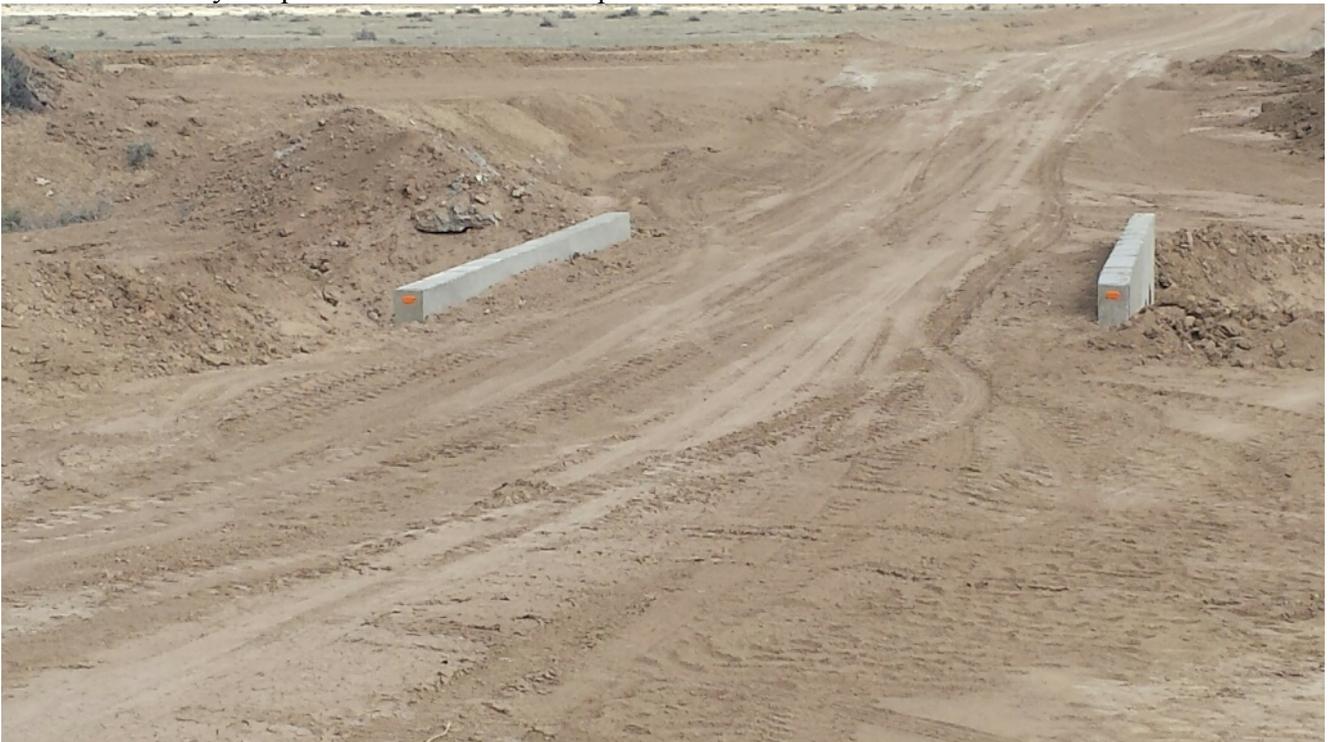
This photos shows reflectors installed on each end of the head and end walls. These should show up brightly at night in a vehicles headlights to warn motorists where the edge of the road is.
(continued)

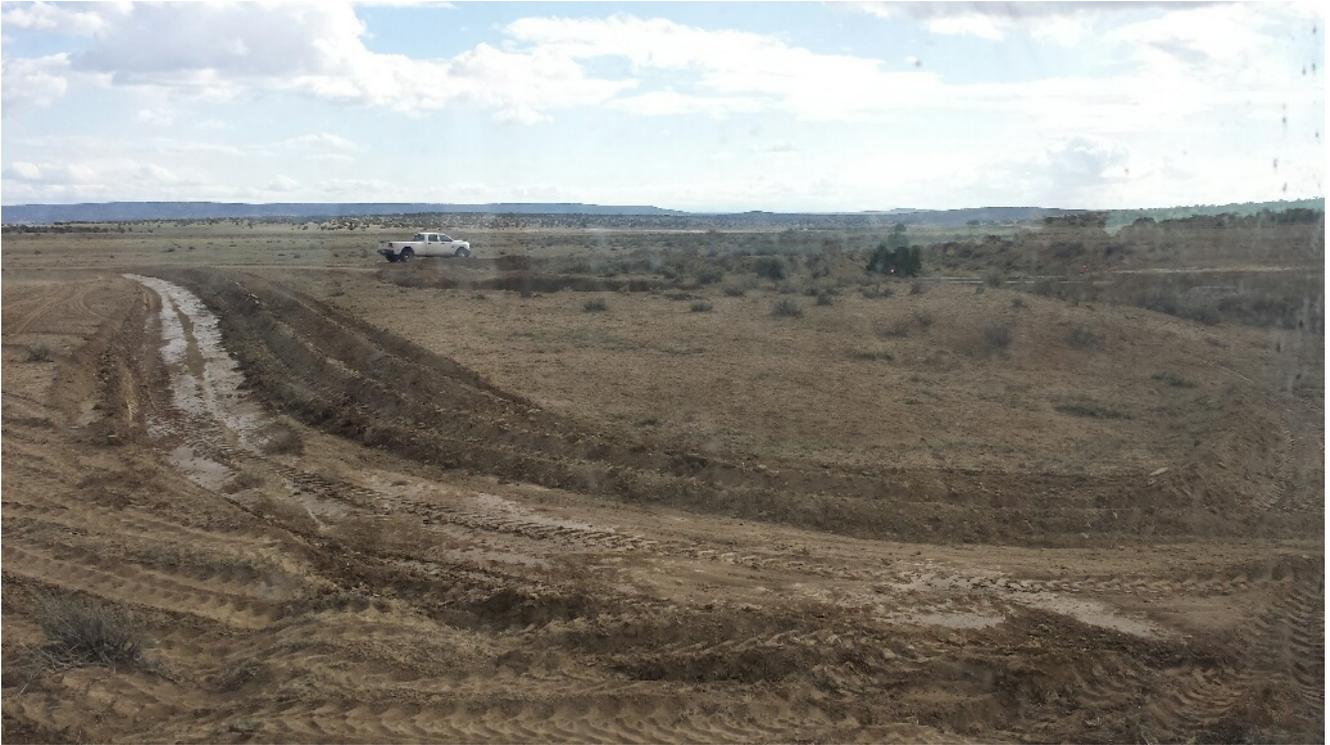
This new water turn out deflects run off from the ditch away from the erosion/waterfall effect that can be seen between the camera and the truck in the background (the photo here does no justice), the new culverts are just out of sight at the right side of this photo. This will buy some time, perhaps a few years before the road is again endangered. This is on the south east side of the Old Meadow Lane/Blanco wash culvert installation. The “water fall effect” causes a lot of erosion at Woodland Valley Ranch. Most never see it because we take preventative measures to try to control it, we are successful most of the time by staying ahead of problems before they become major issues. This saves the POA funds in the long run which can be used to make major improvements such as the Blanco Wash culvert installation.
